## **WILTS & BERKS CANAL MELKSHAM LINK**

### **Tree Survey and Implications Assessment**

**Report by:** Steve Russell BSc (Hons)

**Date:** 2nd September 2012

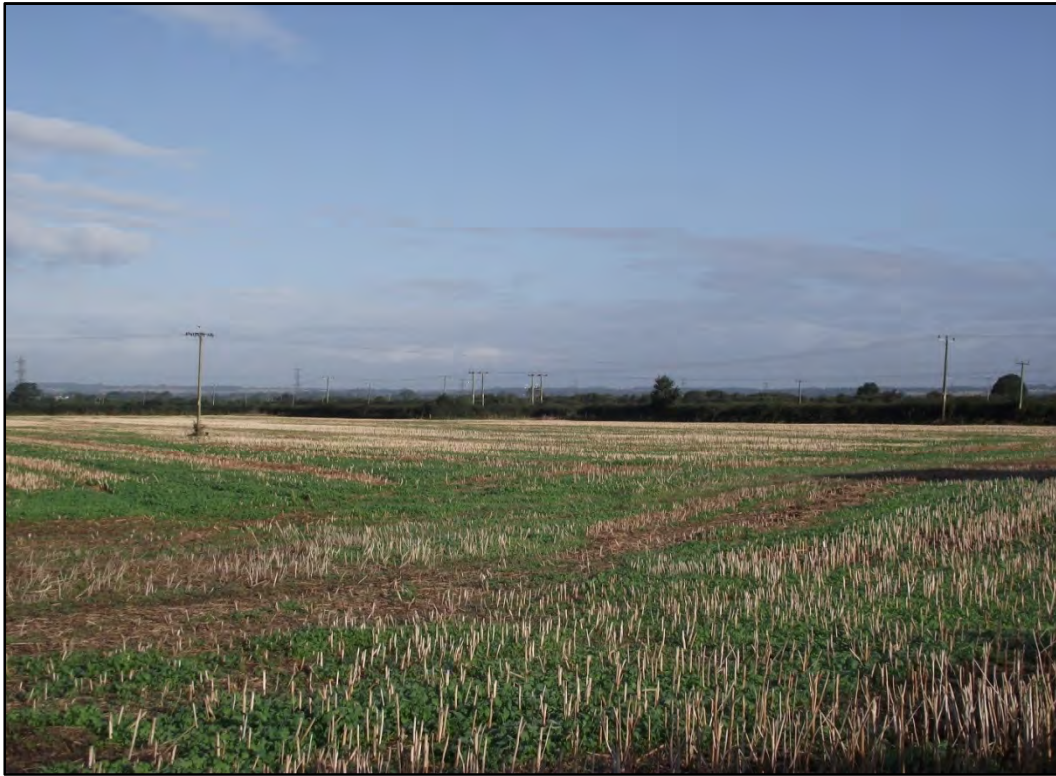
Photograph 1 - View from Semington Bridge north east

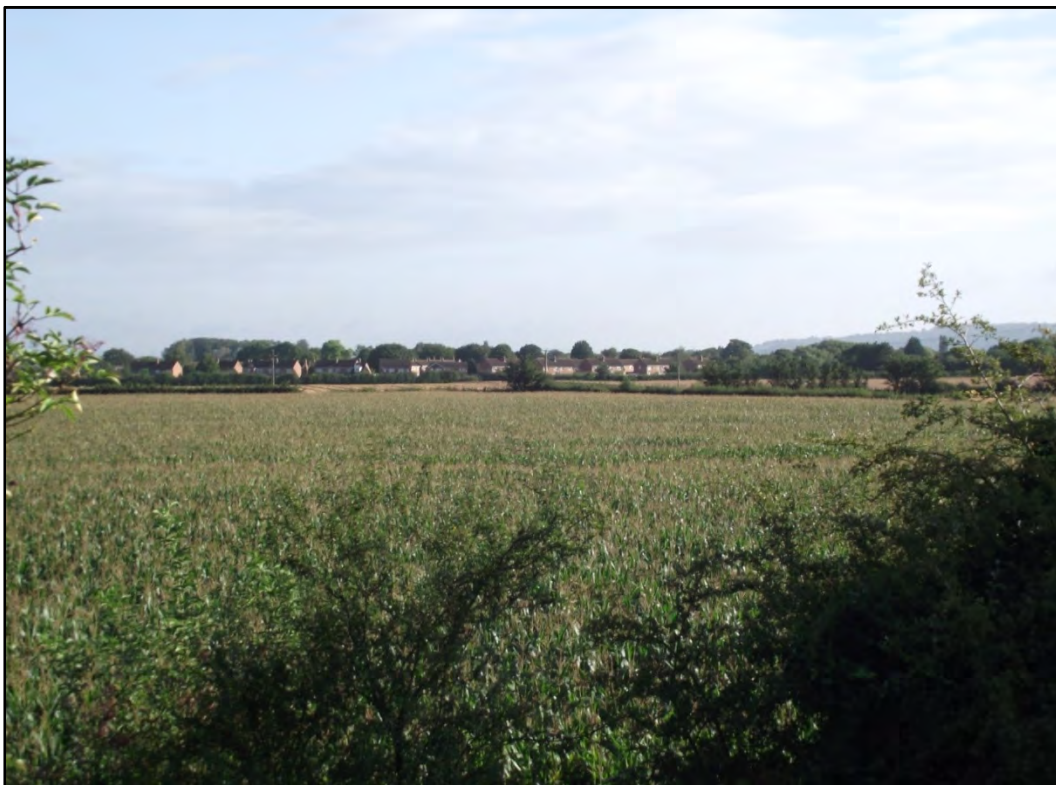
Photograph 2 - View from old railway at Outmarsh Farm towards Berryfield

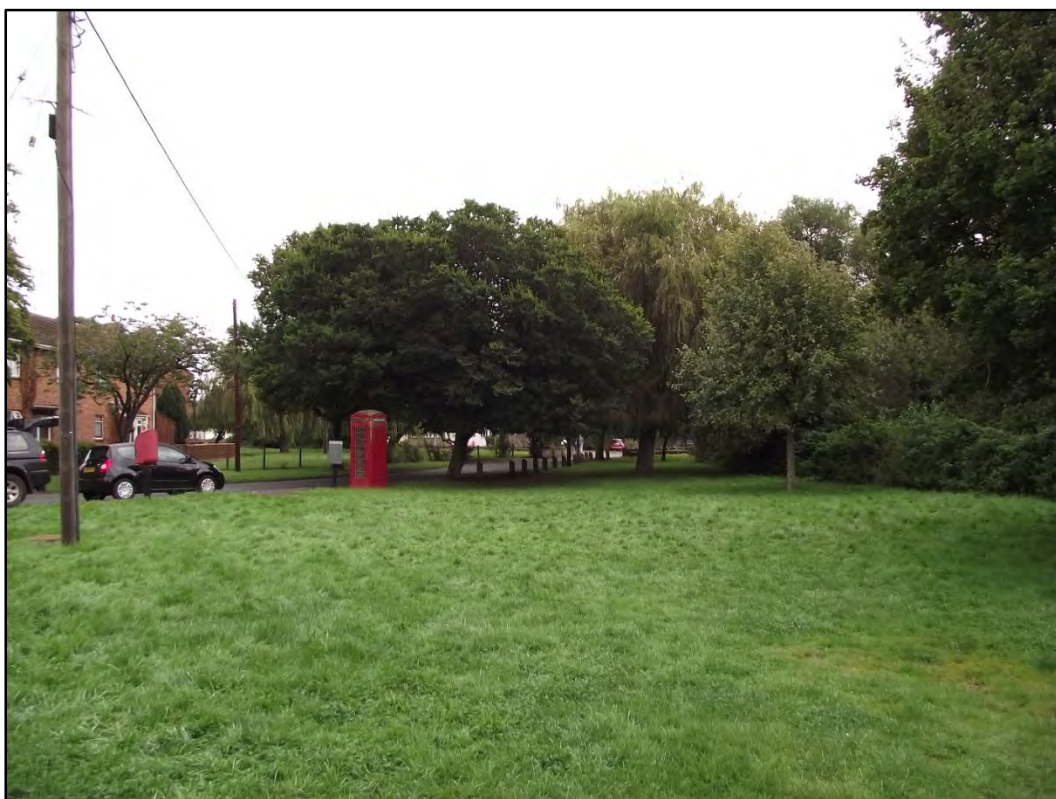
Photograph 3 - View of Berryfield open space

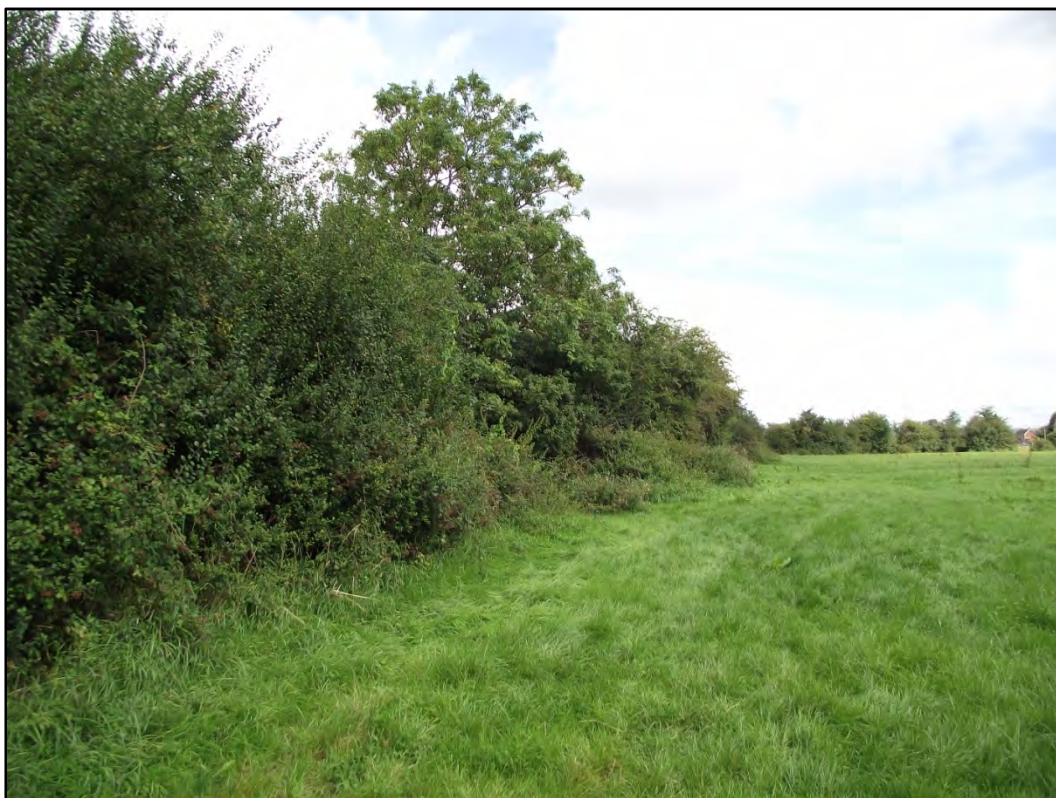
Photograph 4 - View from Berryfield Lane north west along hedgerow

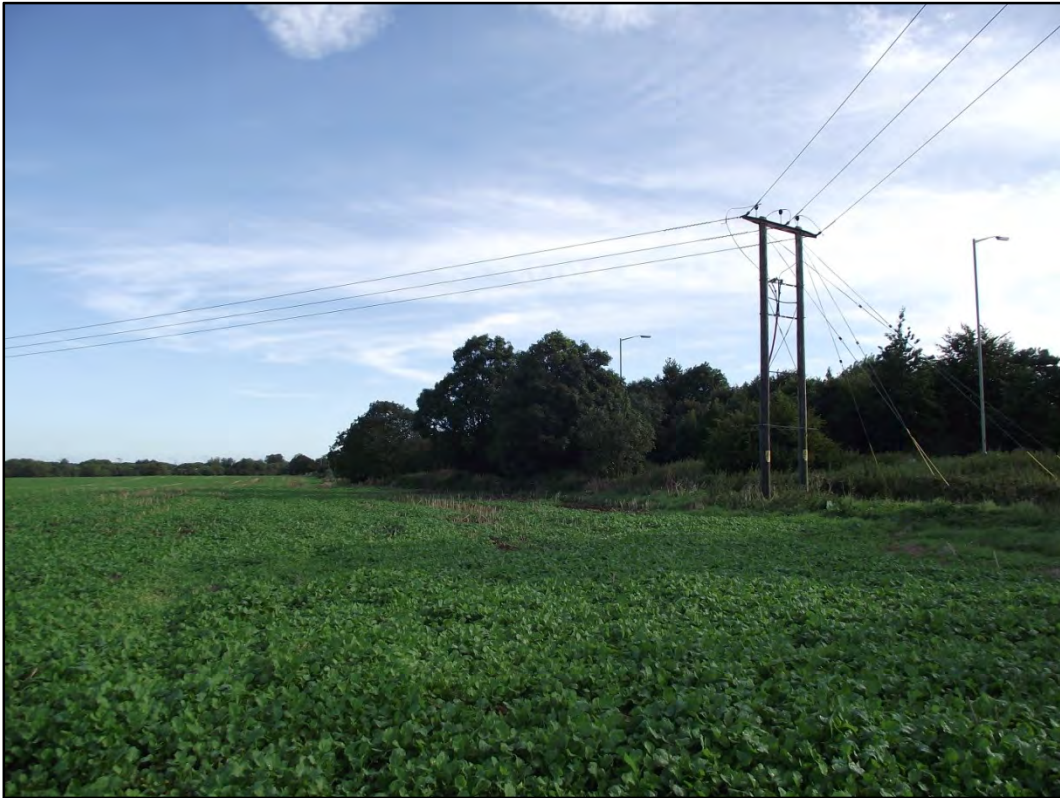
Photograph 5 - View from field north along boundary with A350

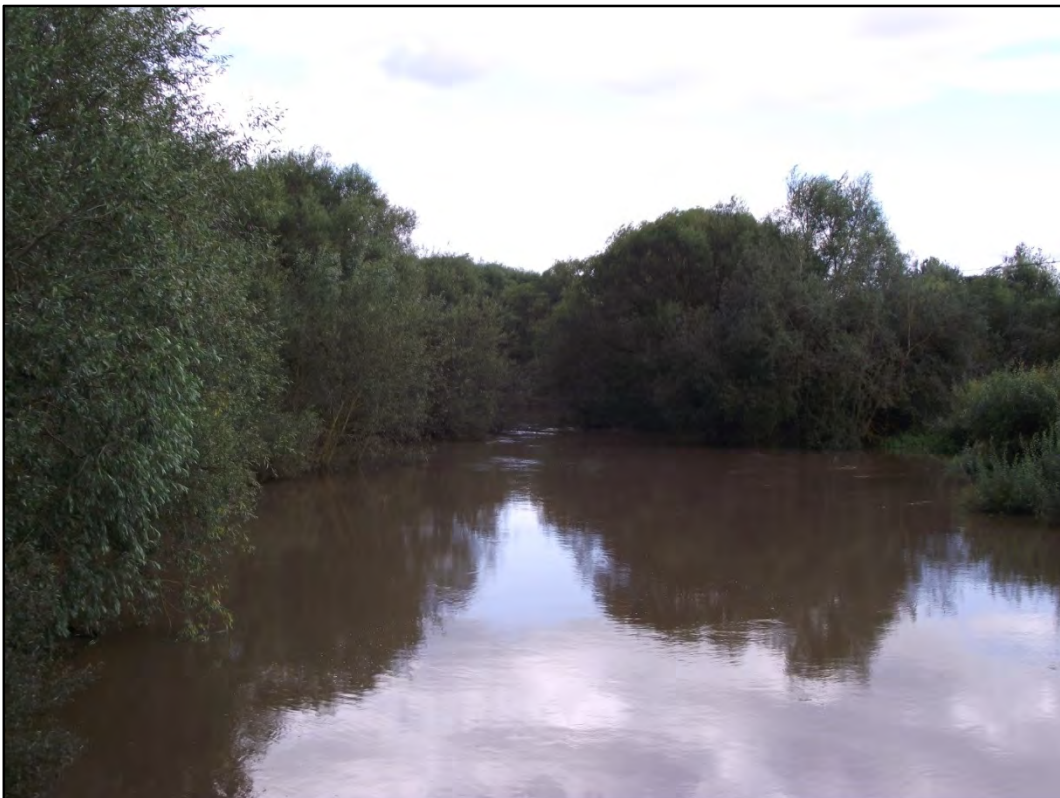
Photograph 6 - View from Challymead Bridge west

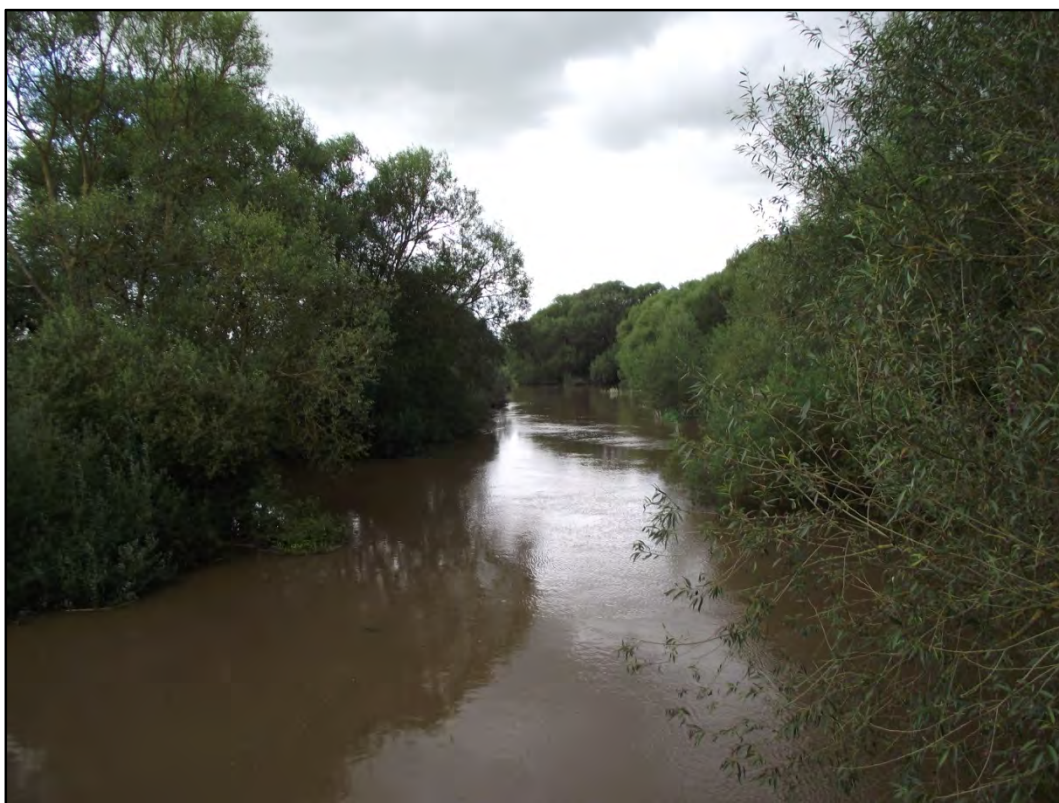
Photograph 7 - View from Challymead Bridge west

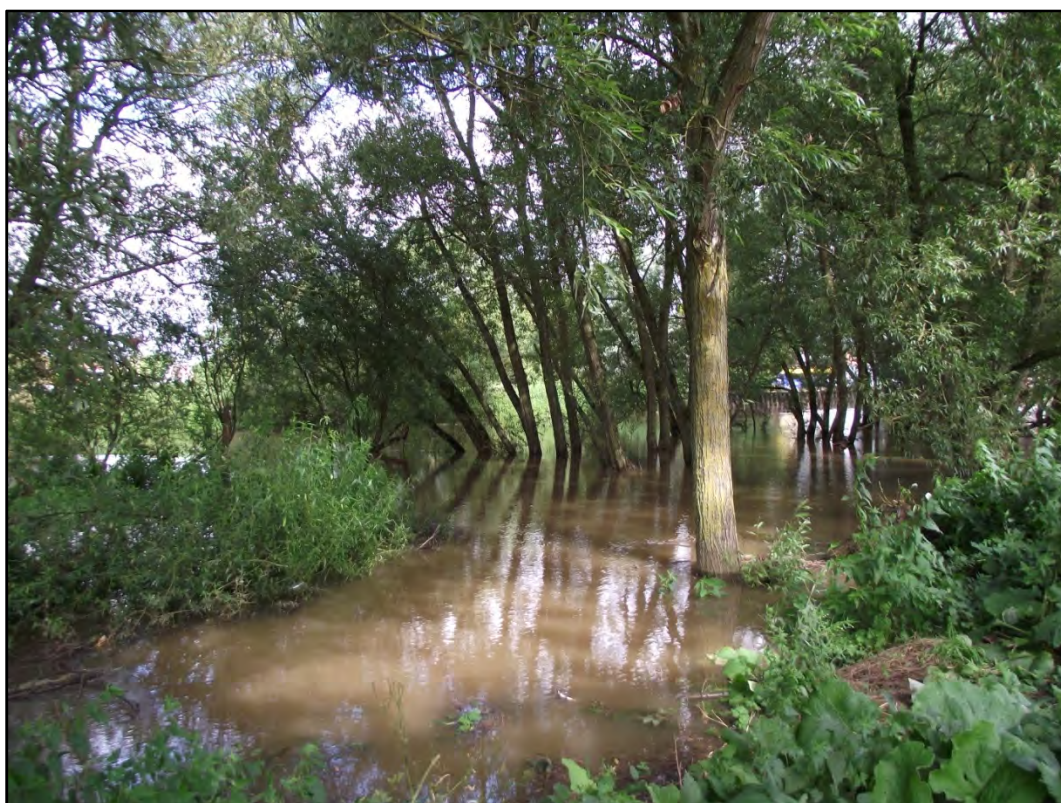
Photograph 8 - View of Crack Willow group

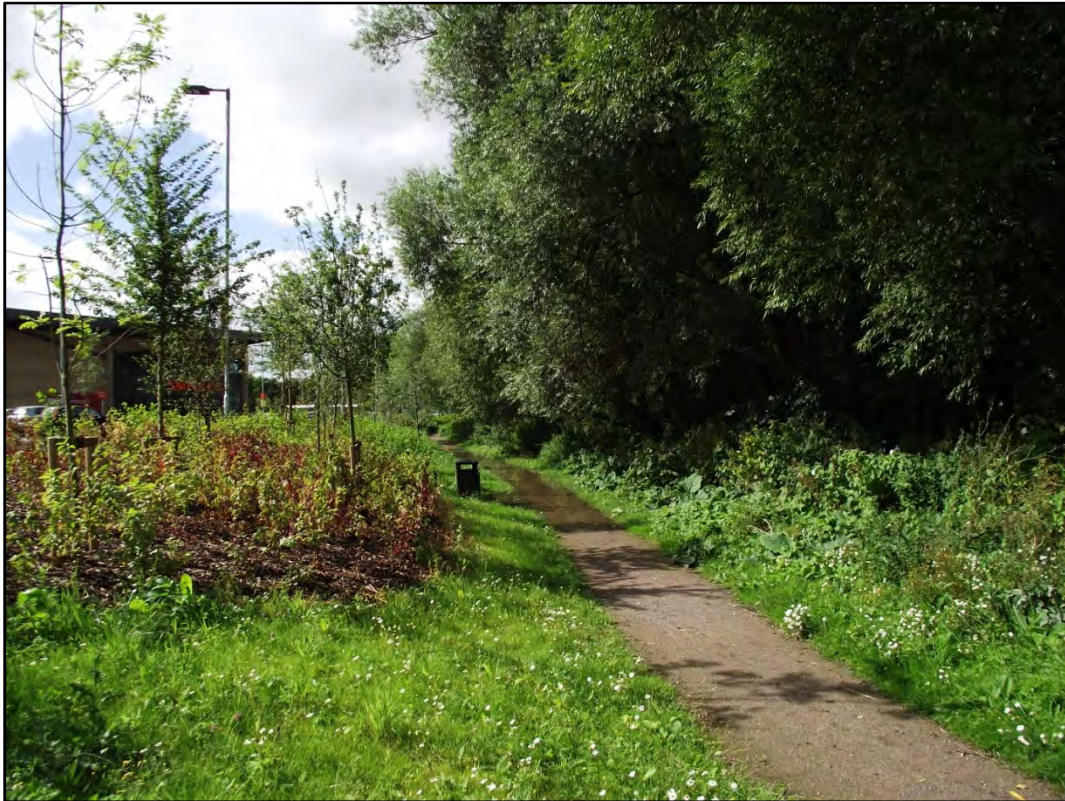
Photograph 9 - View of river path alongside Sainsbury's car park looking south west

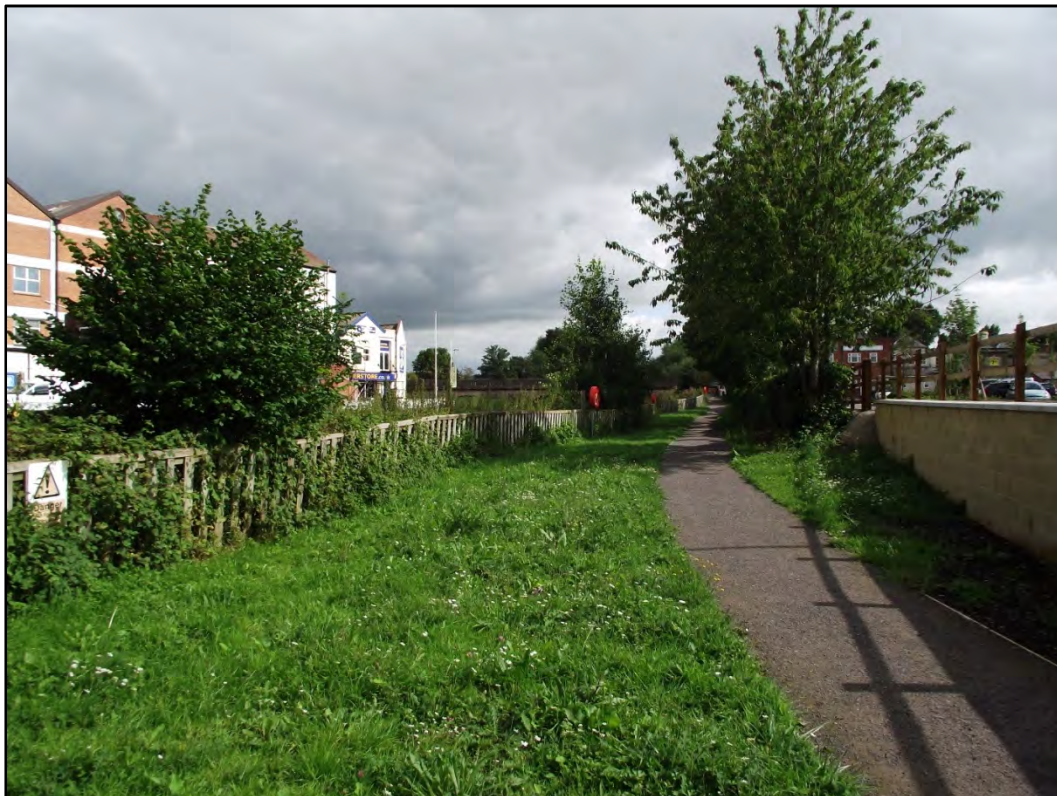
Photograph 10 - View of river path from Sainsbury's looking north east

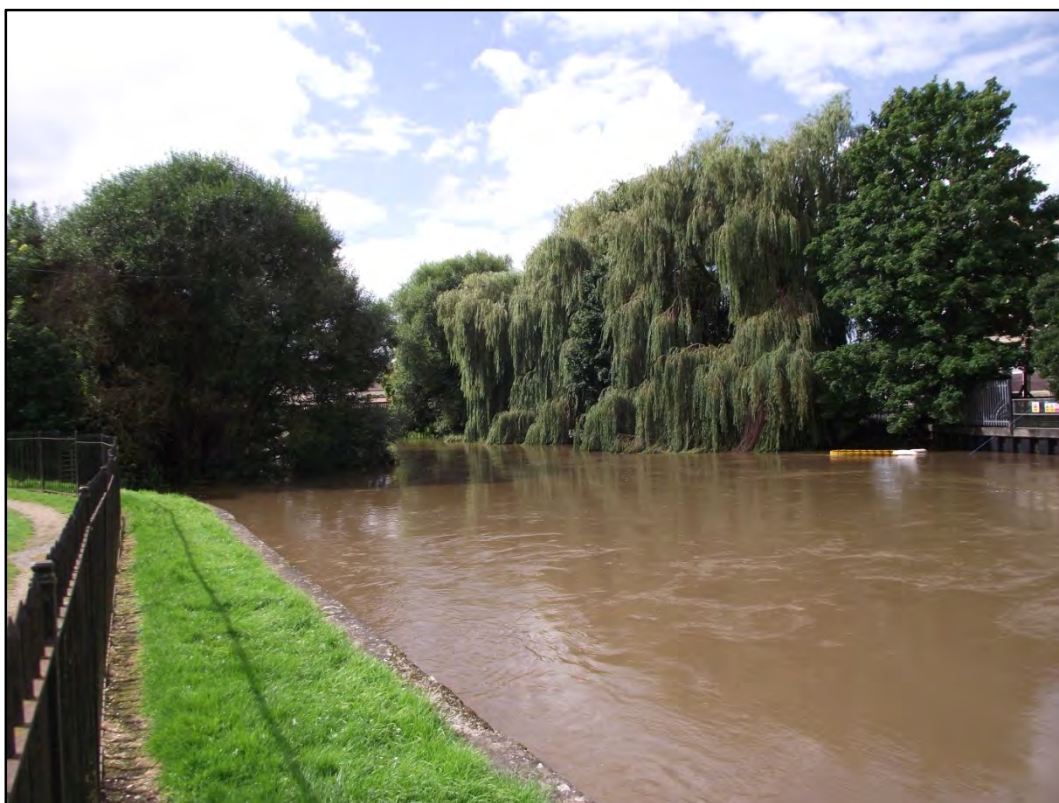
Photograph 11 - View from Recreation ground south west along river

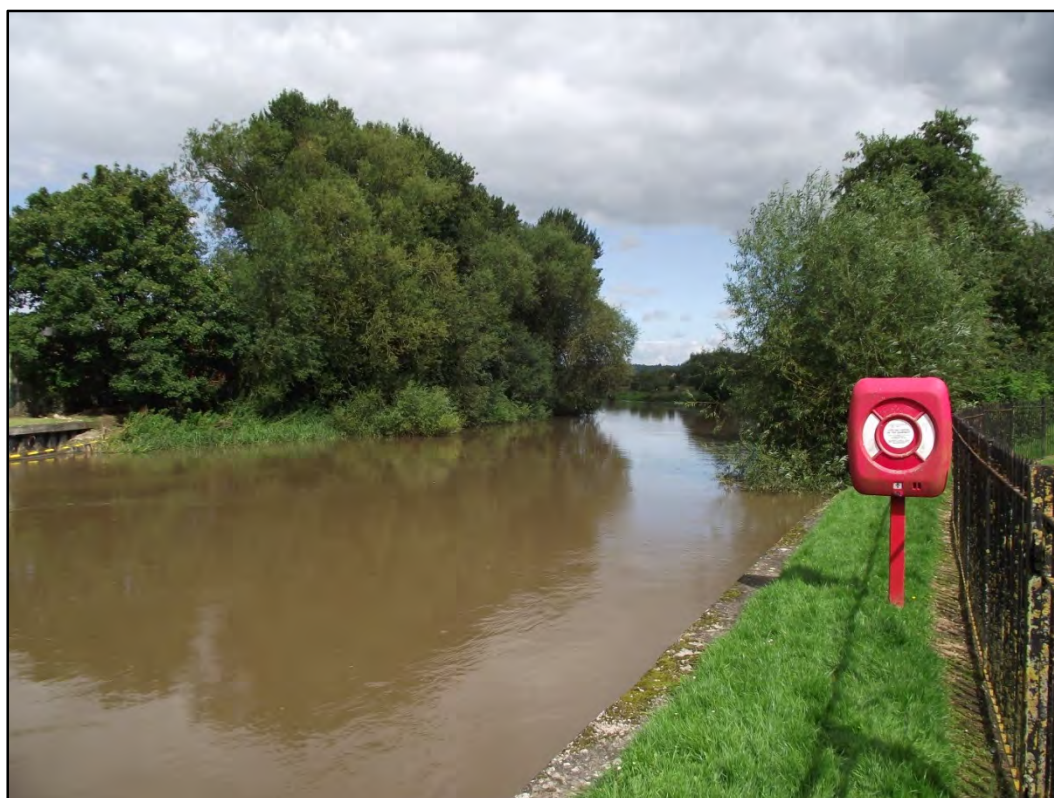
Photograph 1 - View from Recreation ground north east along river
